CARR - 680

MEDFORD GRANGE HALL

c. 1902

FIELD SHEET--HISTORIC RESOURCES SURVEY

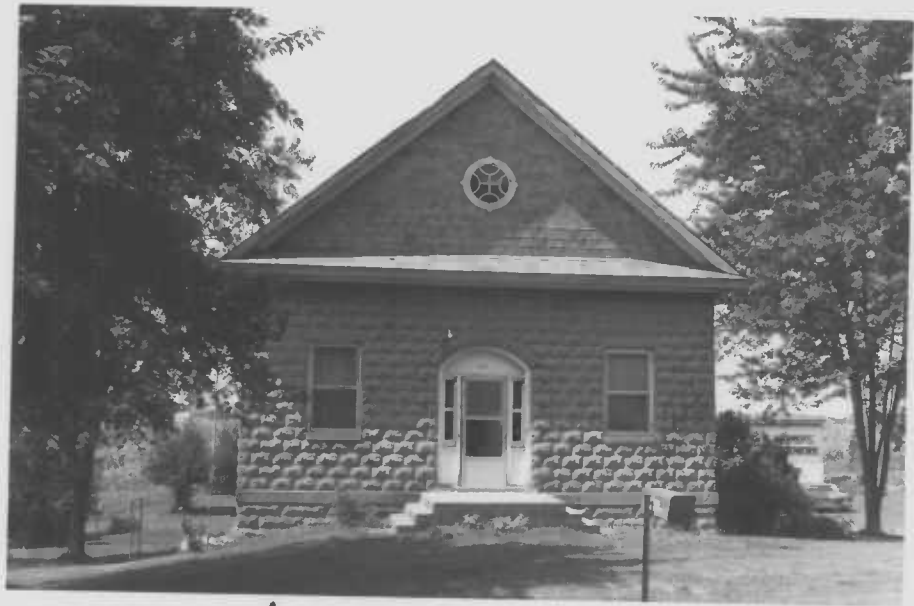
CARR-680

1. Medford Grange Hall
2. Carroll Co Md
3. Joe Betty
4. 8/83
5. Md. Hist. Trust, Annapolis Md
6. east elevation
7. 1/3

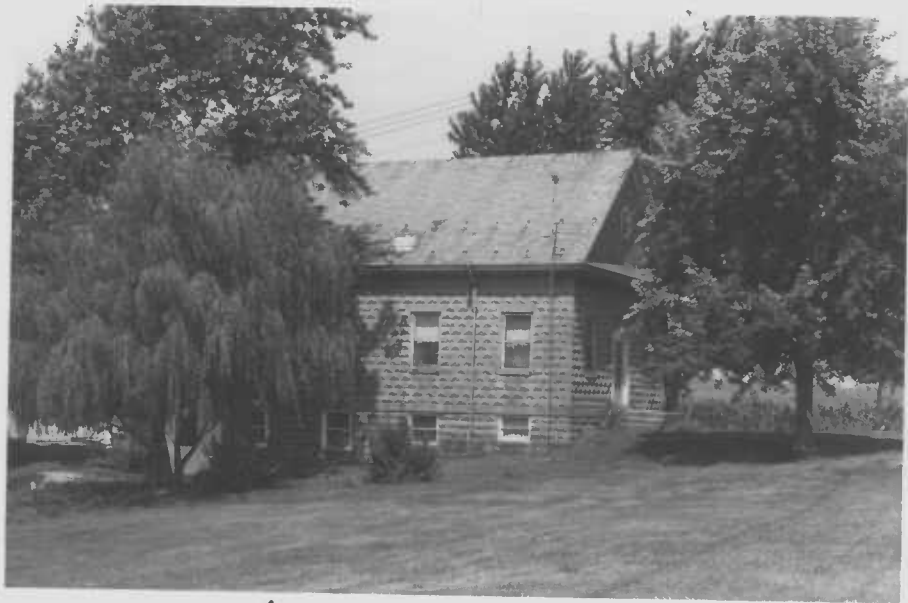
CARR-680

1. Medford Grange Hall
2. Carroll Co. Md.
3. Joe Getty
4. 8/83
5. Md. Hist. Trust Annapolis Md
6. south elevation
7. 2/3

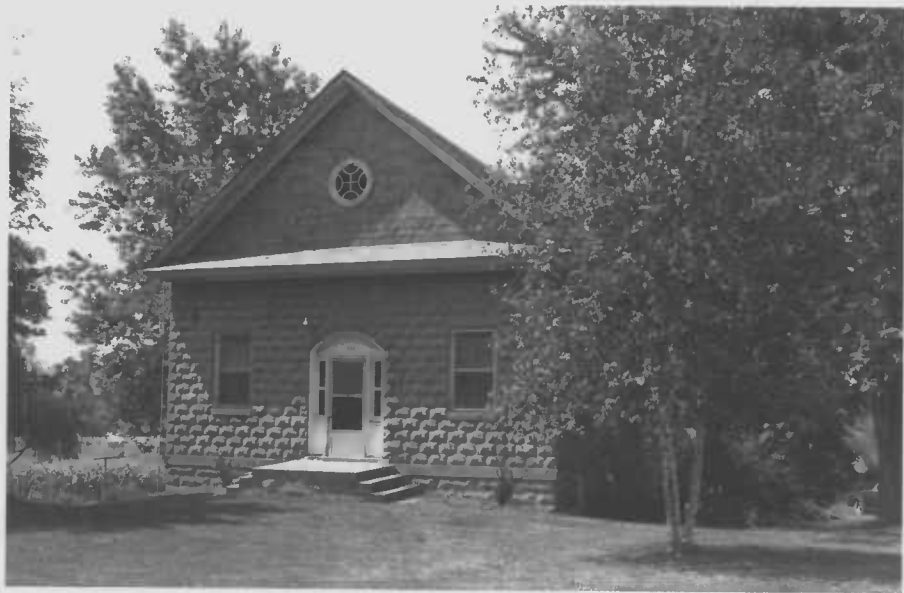
CARR-680

1. Medford Grange Hall
2. Carroll Co. Md.
3. Joe Getty
4. 8/83
5. Md. Hist. Trust, Annapolis Md
6. east elevation
7. 3/3
